SURVEYOR III PARTS AND MATERIALS/EVALUATION OF LUNAR EFFECTS

RETURNED FROM THE MOON BY APOLLO XII

SUBMITTED 22 JANUARY 1971

P 70-54
(SSD 00628R)

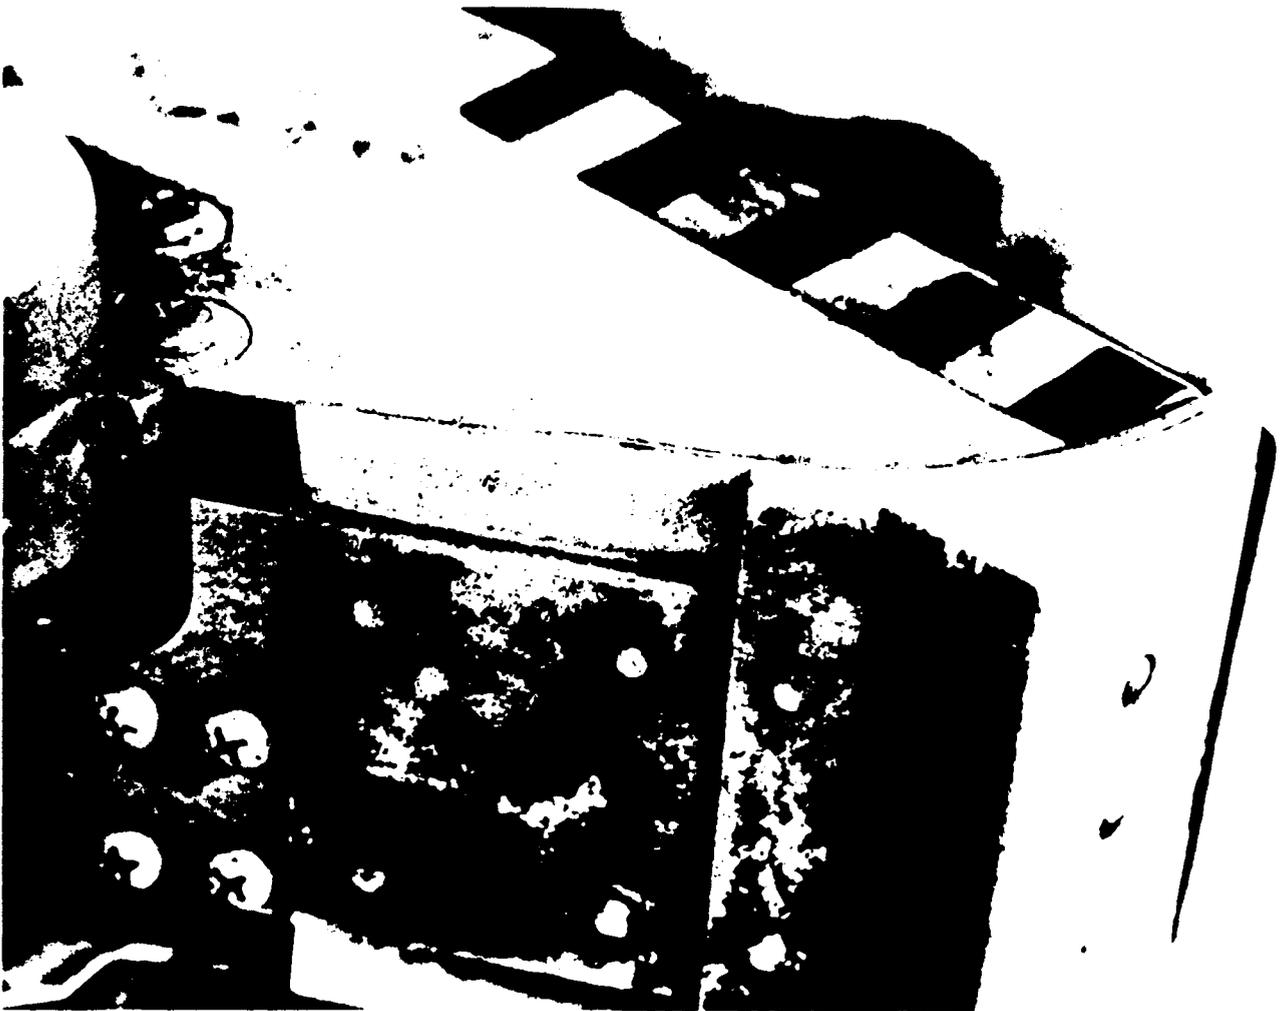
Figure 3-5. Distribution of Lunar Material on SM/SS Scoop
(Photo 4R14815)

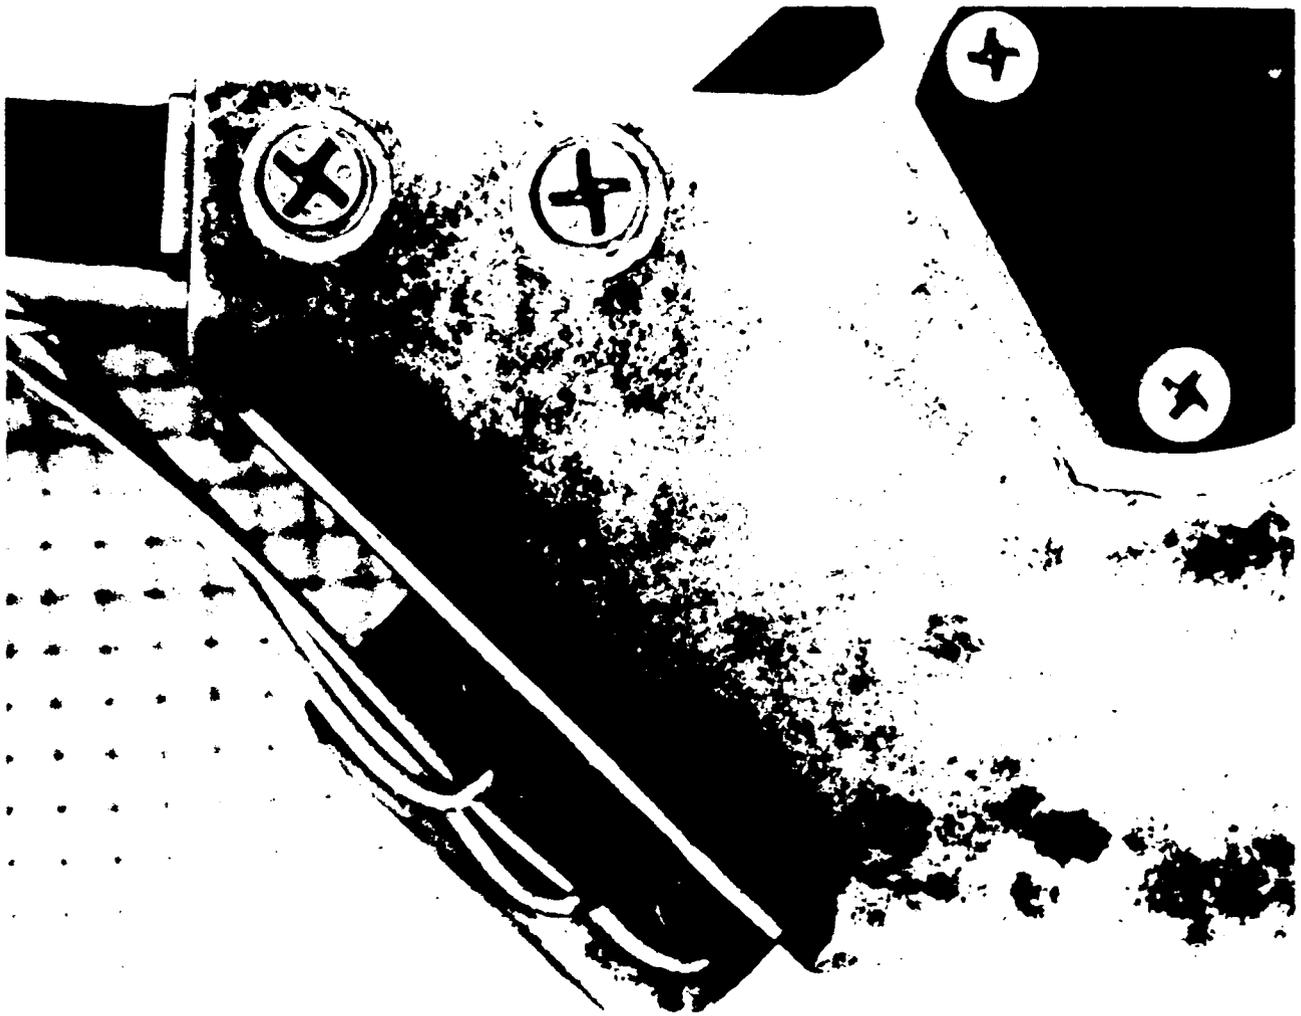
Figure 3-6. Enlarged View of SM/SS Scoop, Showing Lunar Material and Wiring (Photo 4R15123)

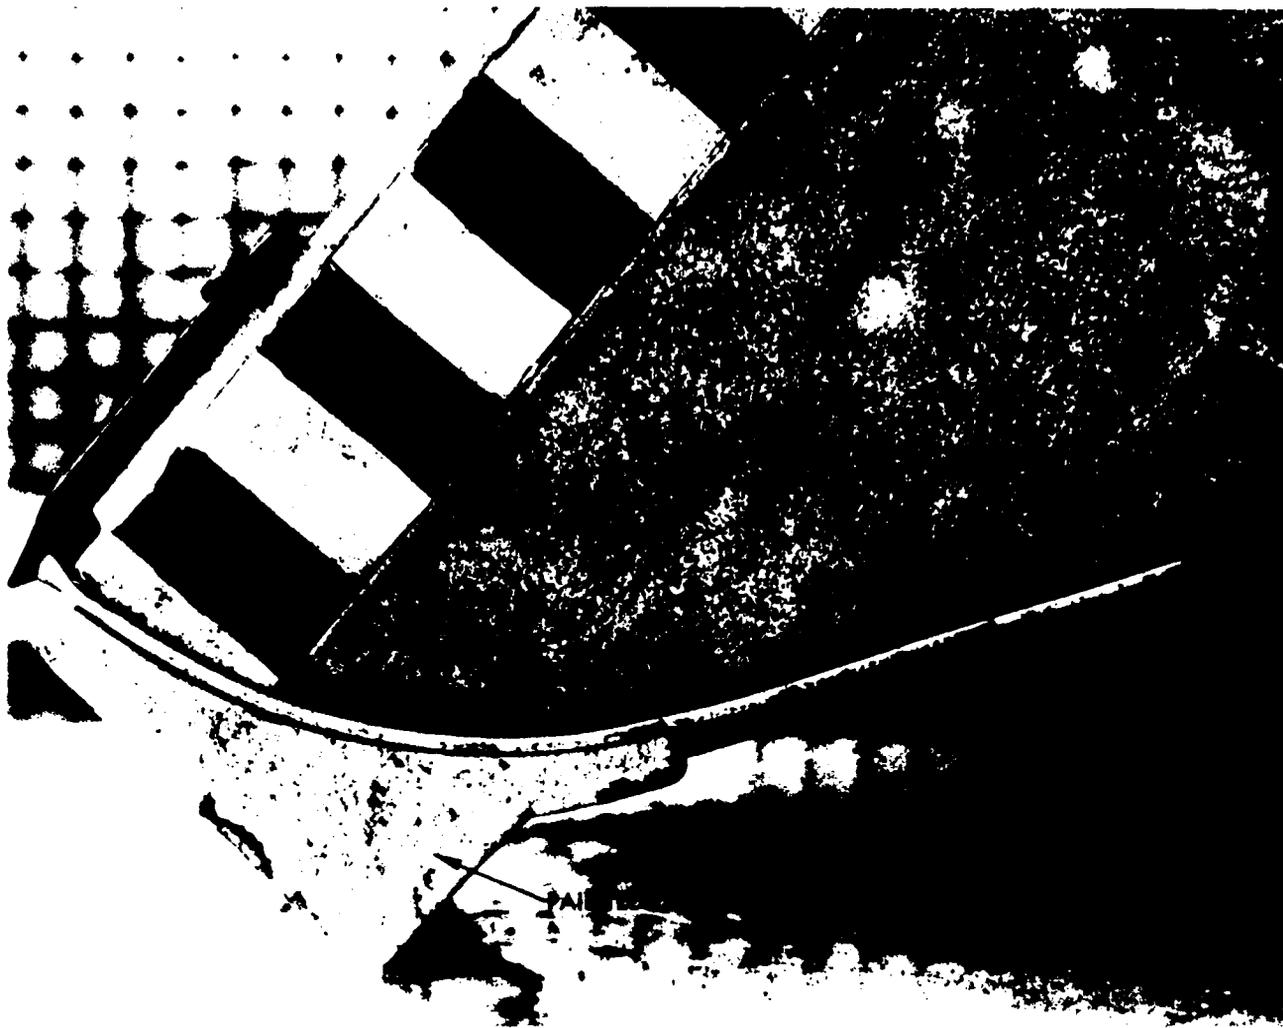
Figure 3-7. "Mud-Cracking" of SM/SS Scoop Paint (Photo 4R15118)

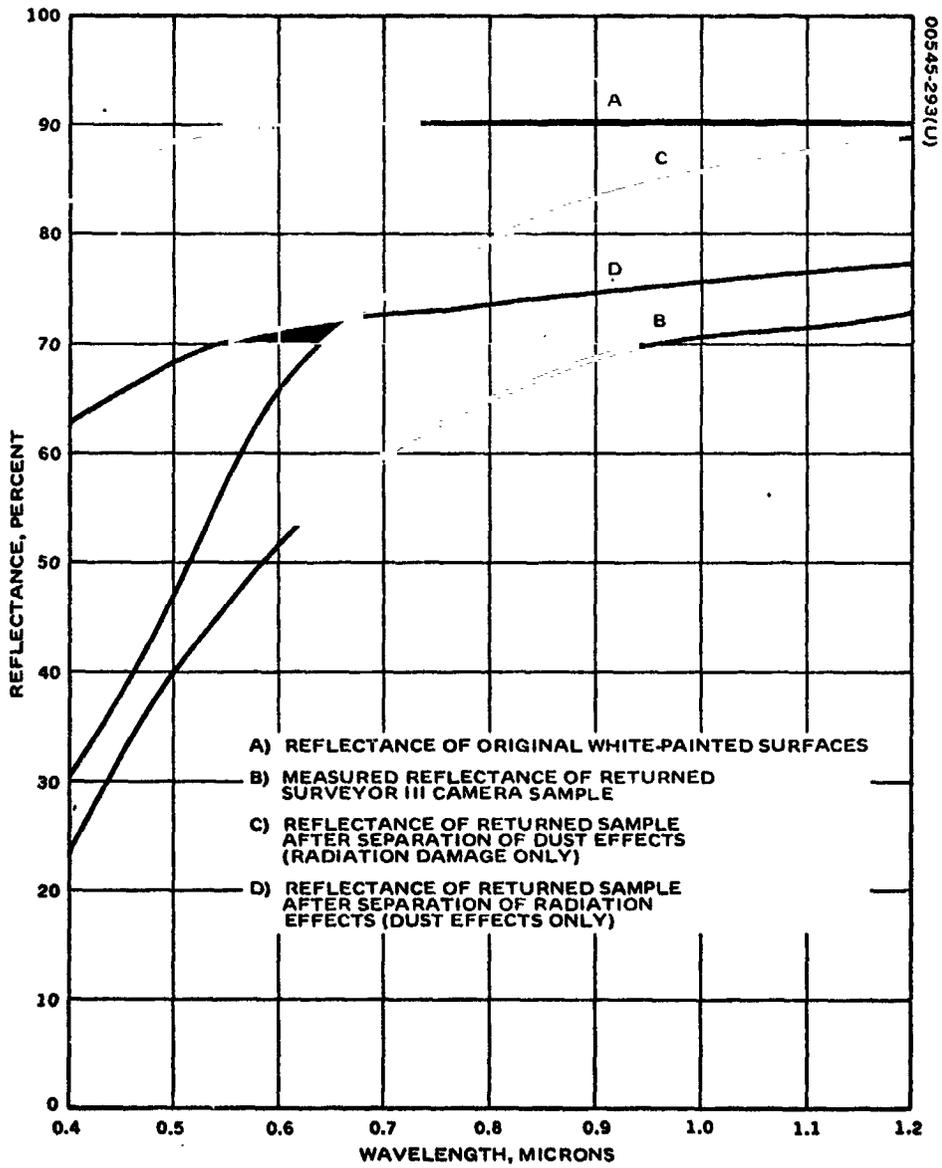
Figure 11-3. Separated Radiation and Dust Effects on Spectral Reflectance.
 White inorganic painted surfaces of Surveyor III camera

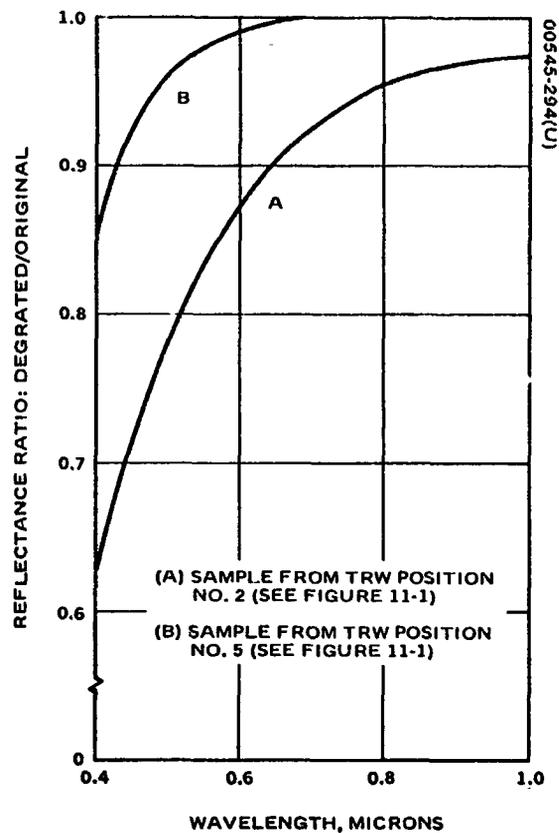
As reported above, it was reasonably possible to isolate by measurement and analysis the contributions of the lunar dust coverage from the total reflectance from the painted surfaces. This made it possible to separately analyze the patterns of discoloration and damage attributable to solar radiation only. As illustrated in Figure 11-4, it was then verified that the discoloration in the paint attributable to radiation effects is indeed proportional to the degree of solar exposure. The two locations on the lower shroud of the camera, positions 2 and 5 in Figure 11-4, correspond to areas of near-maximum and near-minimum solar exposure, respectively.

Figure 11-4. Effect of Radiation on Spectral Reflectance of White Inorganic Painted Surfaces of Surveyor III Camera (Contributions of Lunar Dust Removed Analytically)
